Investigation of a breached levee

A multidisciplinary investigation involving visual, morphological, geophysical and geotechnical methods was applied to a previously breached levee in NW Belgium.

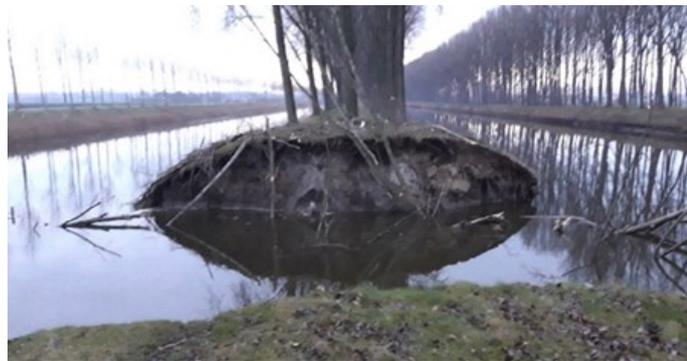
Figure 4: Breached central levee, end 2018.

The investigation gave insight in the spatial extent of the (severity of) damage and its temporal evolution. Different factors contributing to the 2018 failure were identified: erosion of levee toe and slope, presence of burrows and old tree trunks, combined with an elevated hydraulic gradient between the canals leading to increased risk for piping and slope instability. Zones of increased vulnerability were identified based on the integration of all applied non-destructive methods and confirmed by limited drilling and CPTs.

After the investigation, restoration and strengthening works of the levee were planned and are currently underway.

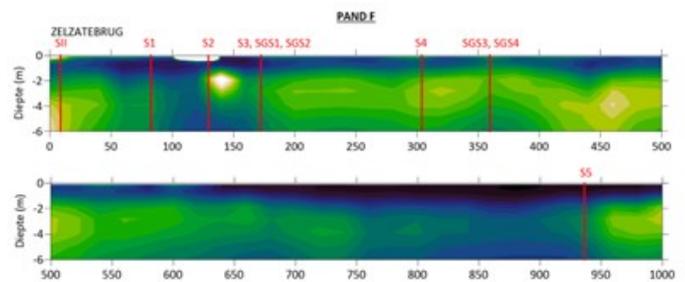
Figure 6: Example of the EM conductivity pseudo-2D profile.

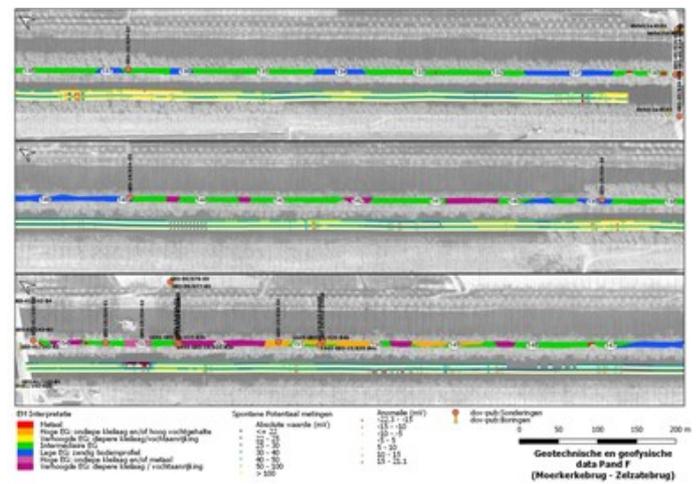
Figure 7: EM soil structure interpretation layer.
