Monitoring a full-scale backward erosion piping field test at Hedwigepolder

Two full-scale backward erosion piping field tests were executed in the Hedwigepolder, The Netherlands. The tests were aimed to further validate the hypothesis that tidal sand has more resistance to piping than fluvial sand. Tidal sand has relatively high percentages of fines (clay, silt), often contains discrete clay and silt layers, is more cohesive, more anisotropic and has a higher critical shear stress than fluvial sand. Piping was initiated by infiltrating water into a completely enclosed body of tidal sand. This was done using infiltration tubes on one side of each test site, while at the other side a ditch was dug down to the tidal sand layer. By gradually increasing water levels in the tubes, an increasingly steep water pressure gradient was formed in the sand initiating backward erosion piping. The piping process was monitored using an array of techniques, including Electrical Resistance Tomography (ERT), Distributed Temperature Sensing (DTS), over 200 piezometers and infrared cameras. After the test the entire site was excavated to track the route of the pipe and to study the subsurface in detai

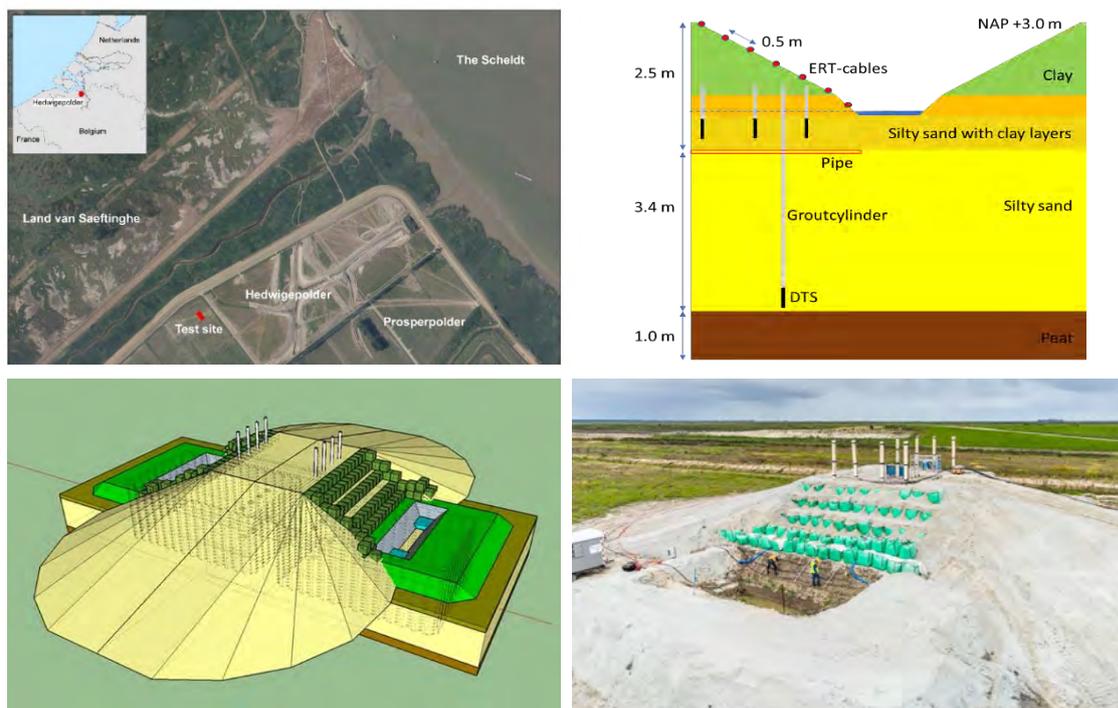
Figure 1: Top left: Location of the Hedwigepolder and test site. Top right: general lay-out of the confined tidal, silty sand aquifer and experimental set up of the monitoring system. Bottom left: design of the test site. Bottom right: Actual test site. The infiltration tubes are visible on the top of the artificial embankment and in the centre one of the ditches is visible. On the other side of the test site a similar ditch is present. Below the mound two rectangular areas of 12*20 m are enclosed with sheet piles, meaning that two separate tests can be executed. In each test section 4 infiltration tubes are used to create a hydraulic gradient in the sand. The two persons are installing the ERT-cables in between the ditch and the BigBags. All the other monitoring was installed before the construction of the artificial embankment and is not visible.

The field test was executed in the Hedwigepolder, The Netherlands (Fig. 1). This polder is used for research in a Living Lab setting (<https://polder2cs.eu/activities>) before it will be transformed in a new tidal nature reserve. A site was selected for the backward erosion piping experiments based on boreholes, cone penetration tests (CPT's) and ERT measurements, HPT-AMPT® tests and two trenches in which the local subsurface was investigated in detail. At the chosen location the thickness of both the aquifer and the confining aquitards were largest. In preparation of the experiment sheet piles were installed to create two test sections of approximately 12 by 20 metres in which the tidal sand aquifer was enclosed on all sides. 4 infiltration tubes were installed on the "upstream" side of each section in which the water levels could be regulated using pumps. At the toe of the dike a ditch was created reaching the top of the aquifer (Fig. 1). To prevent leakage all sheet piles were installed using bitumen in the interlocks and the top of the piles was covered by 1 m clay. A large body of sand in combination with BigBags was used to prevent uplift and hydraulic fracturing of the clay cover layers and gave the site the feel of an embankment. By gradually raising and maintaining water levels in the tubes and pumping away seepage water from the ditch, the hydraulic gradient across the tidal sand was gradually increased. At a certain gradient sand boils formed and by further increasing the gradient the piping process proceeded.

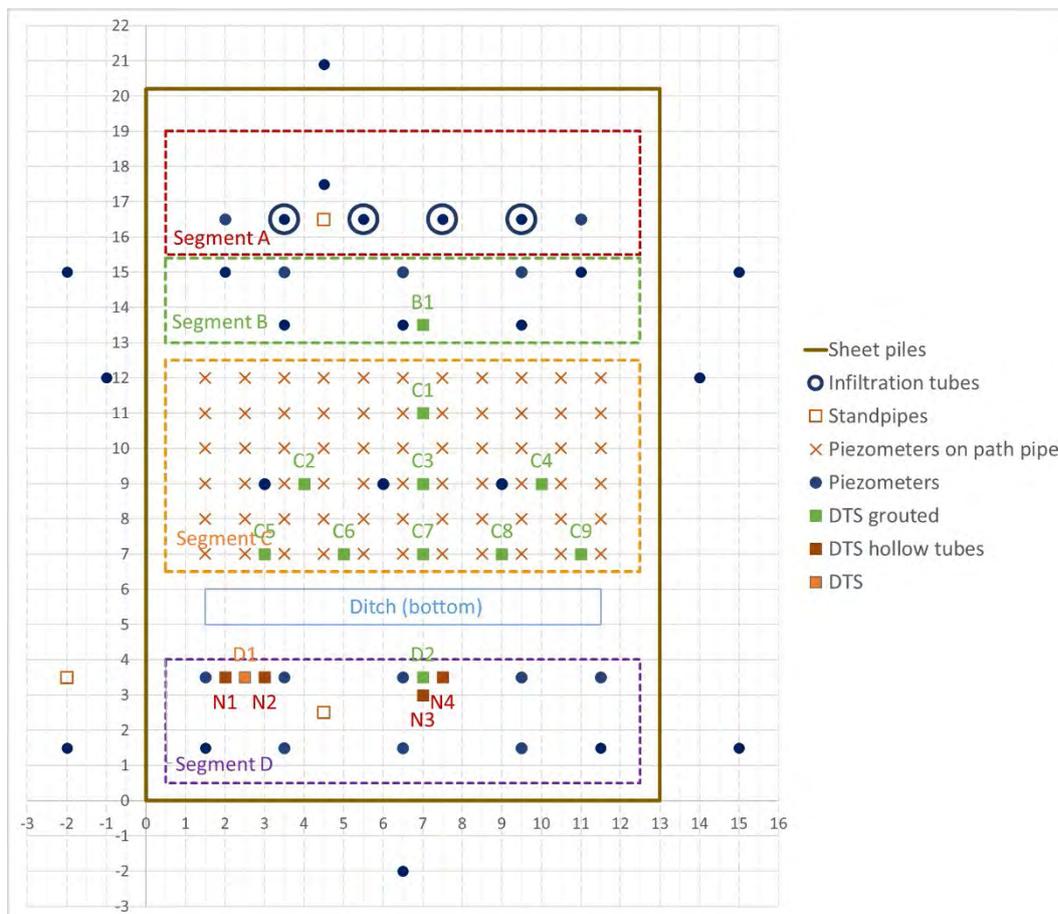
Figure 2: Schematic representation of monitoring set-up piezometers and monitoring wells for one test section. Both test sections are identical with regards to set-up of the experiment and monitoring system.

In total 204 piezometers and 13 monitoring wells were installed to monitor the hydraulic heads in and outside the two test sections at different depths. According to the different objectives of the head monitoring each test section was divided in segments 'A' to 'E' (Fig. 2). Within segments A, B, D and E piezometers were placed relatively deep in the tidal sand or deeper layers to evaluate pressure build up in the multi-layered tidal aquifer and to check whether leakages through the sheet piles or underlying peat layer to the surrounding area (Area E lies outside the sheet-pile construction). In order to follow the pipe a total a total of 66 piezometers were installed in a 1 m grid in segment C. The piezometers in this segment were installed just below the top of the tidal sand layer and hence close to the expected pipe level. The 1Hz monitoring data was logged, made available live on site for the field teams as well as online for colleagues off-site using Fugro's visualisation platform.

At 4 locations (Fig. 2: N1 to N4) CPT-rods were installed, which stayed in place during the experiment, serving as hollow tubes accessible for glass fibre cables to perform passive DTS-measurements. To avoid leakage along the rods in the principal test area, the rods were installed behind the ditch, together with a grouted glass fibre cable (D2) and a glass fibre cable directly in contact with the subsoil (D1). This location is suboptimal to detect temperature changes due to piping, however, the objective of these locations was to compare the different measurement techniques.

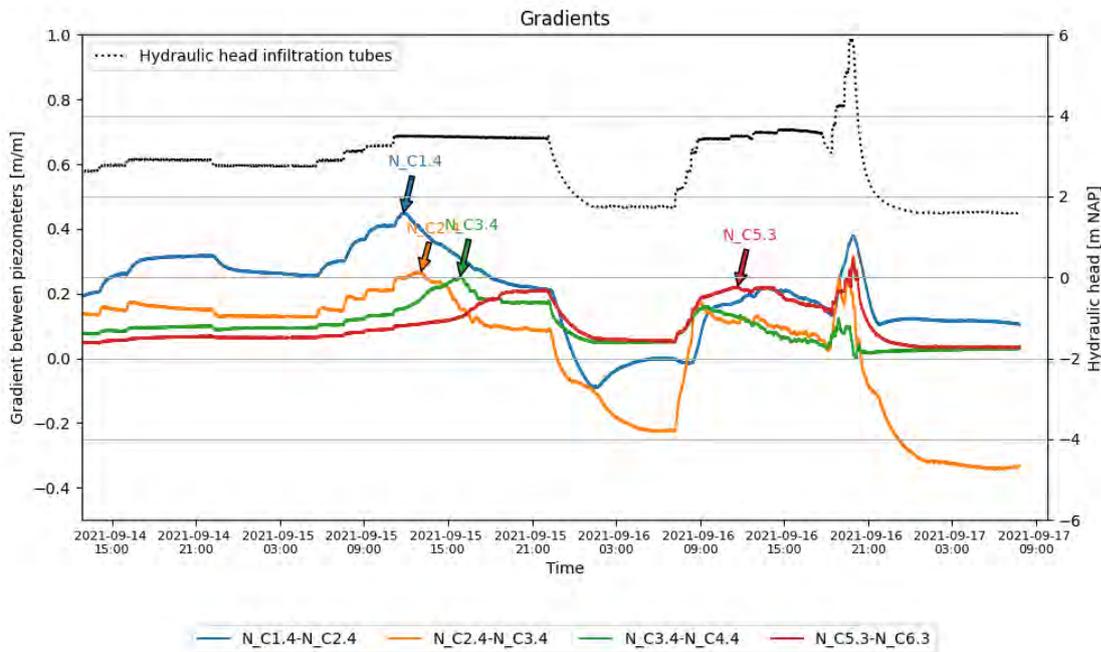
Figure 3: Increase and relatively sudden decrease of head gradients between pairs of piezometers indicating a growing erosion pipe nearby.

During the experiments the location of the erosion pipe's tip was determined using relatively sudden local head drops in the piezometers in segment C. The pipe's growth rate is determined by evaluating pairs of piezometers along the trajectory of the pipe from the downstream (ditch) till upstream side (infiltration tubes) of the ground water flow. A peak in head gradient between a pair of piezometers indicates the pipe position at the downstream piezometer. Figure 3 gives these peaks in head gradient for a selection of piezometer pairs; the pipe can be seen growing upstream across monitoring segment C from piezometer row 1 to 6 in segment C.

Based on the piezometer data the path of the pipe could be determined during the experiments. This was validated during the post-test excavation of the tests (see §3.5) in which the route of the pipe was mapped in detail. It was found that the (predicted) path of the pipe based on the piezometer data matched perfectly with the actual path.

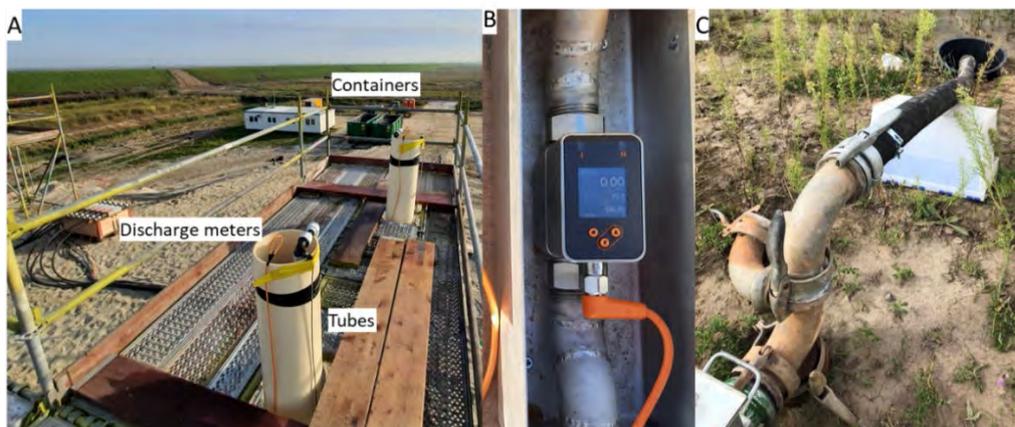
Figure 4 A: Water is pumped from water containers to the infiltration tubes. Each tube had its own pump and each pump has a discharge meter. B: close-up of the digital discharge meter. C: The discharge of the outflow was measured manually by measuring the time needed to fill a container.

The budget of the in and out flowing water is very important to understand and model the piping process but can also show if there is leakage through the sheet piles or along the monitoring systems. The inflowing water was pumped from containers towards the 8 infiltration tubes (Fig. 4).

The system could be set to automatically maintain a desired water level in the tubes, meaning that the pumps became active when water level dropped to a certain water level. Discharge measurements were stored using a logger but could also be read directly in the field. In addition, a piezometer was placed in the water container to measure the decreasing water level and also from this data infiltration discharges could be calculated. This showed that the discharge meters overestimated the discharge, because they didn't record water flowing back to the container after the pumps stopped.

In both ditches a pump was installed that maintained a water level in the ditch of a 5-10 cm. The water was pumped away to an open container and the overflow of this container was connected to a hose with an analogue discharge meter. The analogue meter was read each 30 minutes, but soon it became clear that it was not working properly. Another approach was used whereby the discharge was measured by timing how fast a 30 l container was filled.

- Discharge: The digital discharge meters worked well, but only recorded discharge in one direction. Since the top of the infiltration tubes lies much higher than the container, water flows back to the container, but this negative discharge was not recorded. This can be solved by either using a discharge meter that can record discharge in both ways or install a one-way valve in the hose. For the outgoing discharge, it would be better to install a digital meter instead of an analogue one.

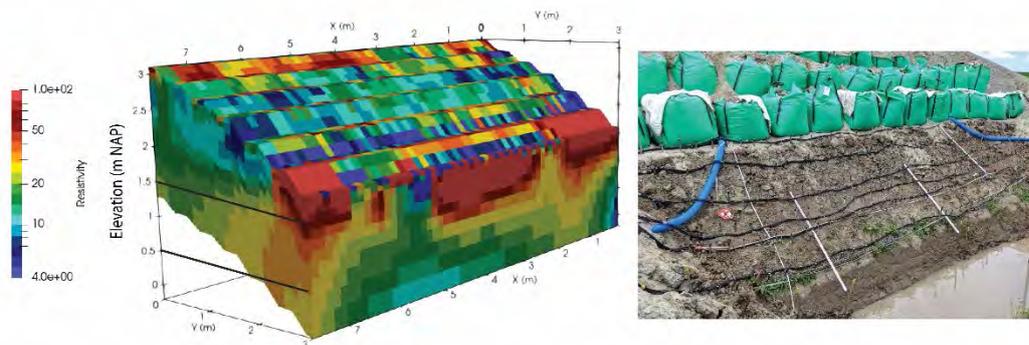
Figure 5: Left: example of the ERT-output. Right: Field site with the black ERT-cables in between the ditch and the first row of green BigBags.

In each test field 7 lines of ERT-cables were placed in between the edge of the ditch and the first row of BigBags (Fig. 5). This area was steeply sloped and hence each line lies at a different elevation and thus distance to the top of the tidal sand. This is not ideal, since this means that the vertical resolution along each line is different at the level of pipe growth. The distance between lines was 0.5 m and the metal pins were placed at 0.25 m intervals. ERT was envisaged to measure the changes in the subsurface in the period before pipe formation started and track the route of the pipe, as pipe growth leads to changing geo-electrical properties. The data could not be used live, but analysis shows that the ERT-data captured the position of the sand boil and the pipe.

- ERT: the cables were positioned on a steep slope and hence the vertical resolution was different at the elevation where the pipe formed and especially higher up the slope the vertical resolution was too low at the elevation of the pipe to detect it. Next time it would be better to build a wider horizontal plateau next to the ditch, so that all cables lie at the same elevation

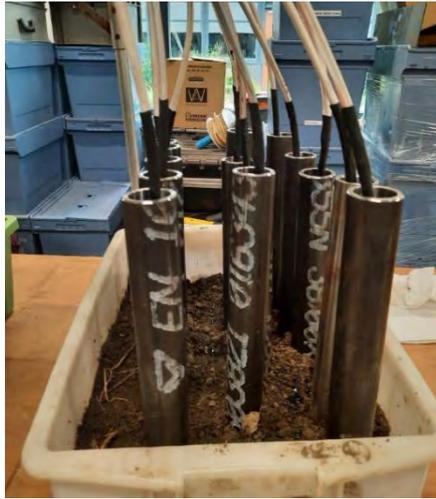
Figure 6: CPT cones with the attached DTS-cables. The cables were spliced together in order to make a loop. The heating cables were also looped.

In the northern test field temperature changes were measured using DTS. At 16 locations active DTS-cables were installed using CPT cones and rods (Fig. 6) by attaching the DTS cable to the cone of the CPT and by pushing the cone to the desired depth and then retracting the CPT-rods while at the same time filling the resulting hole with grout. The hypothesis was that the cooling curve of the heated cables will change (faster cooling) when an erosion pipe is active near a DTS-cable. At present, the analysis is not finished so it is yet unknown whether this hypothesis is true or false.

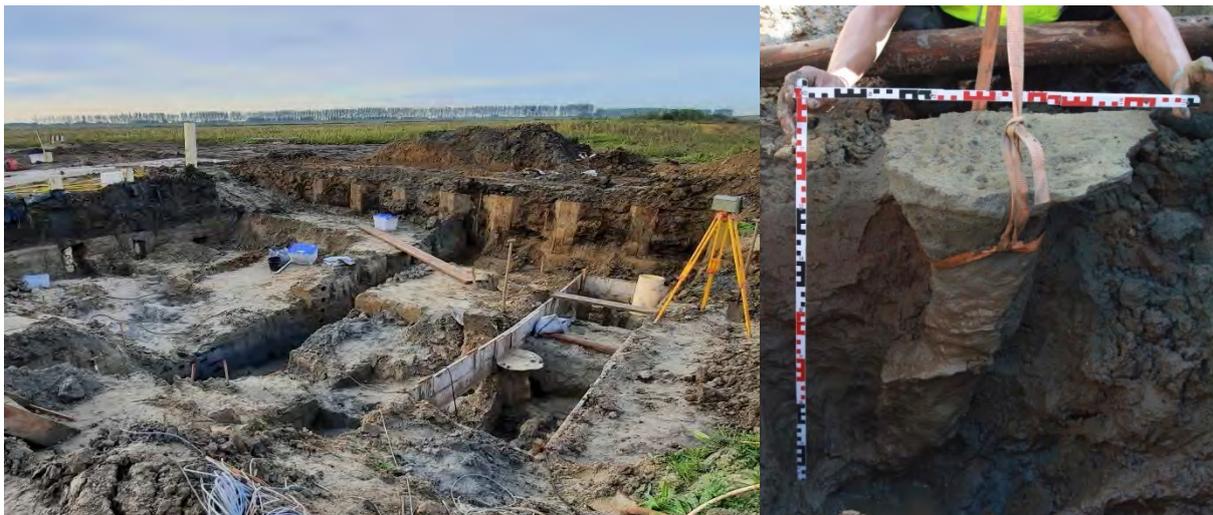
Figure 7: Left: Overview of the excavated northern test site during excavation phase of the experiment. Right: The hardened exit hole in the field.

After the experiments were finished the test field (Fig. 7) was excavated with the aim to find the pipe and measure its dimensions and route. Soil samples were taken and detailed geological descriptions of the subsurface were made. Before groundwater levels were levelled and excavation started, the exit hole was filled with levelling cement, a material that is used to level floors and hardens in water (Fig. 7).
